Lead-Based Paint Inspection & Risk Assessment Report

The Williams House
Lady Slipper Lane
Ivanhoe, Virginia 24350

Report Date: June 30, 2015

EI Project Number: IHRO150106.00

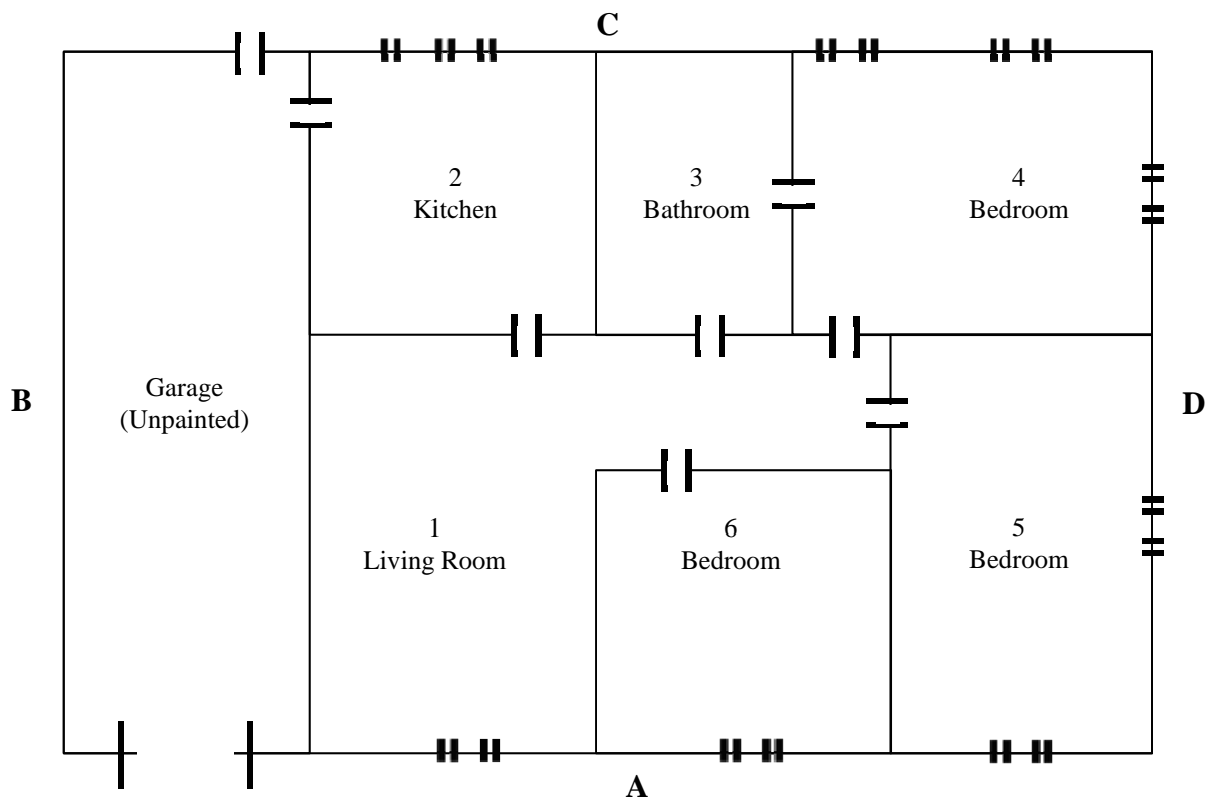
PROPERTY SITE DRAWING

SAMPLE LOCATIONS
